S.6 Chassis Study Group Information Report: 2002-1

Road Chemical Induced Corrosion

Developed by the Technology & Maintenance Council's (TMC)
Ice-Clearing Chemical Induced Corrosion Task Force
Under the Auspices of the S.6 Chassis Study Group

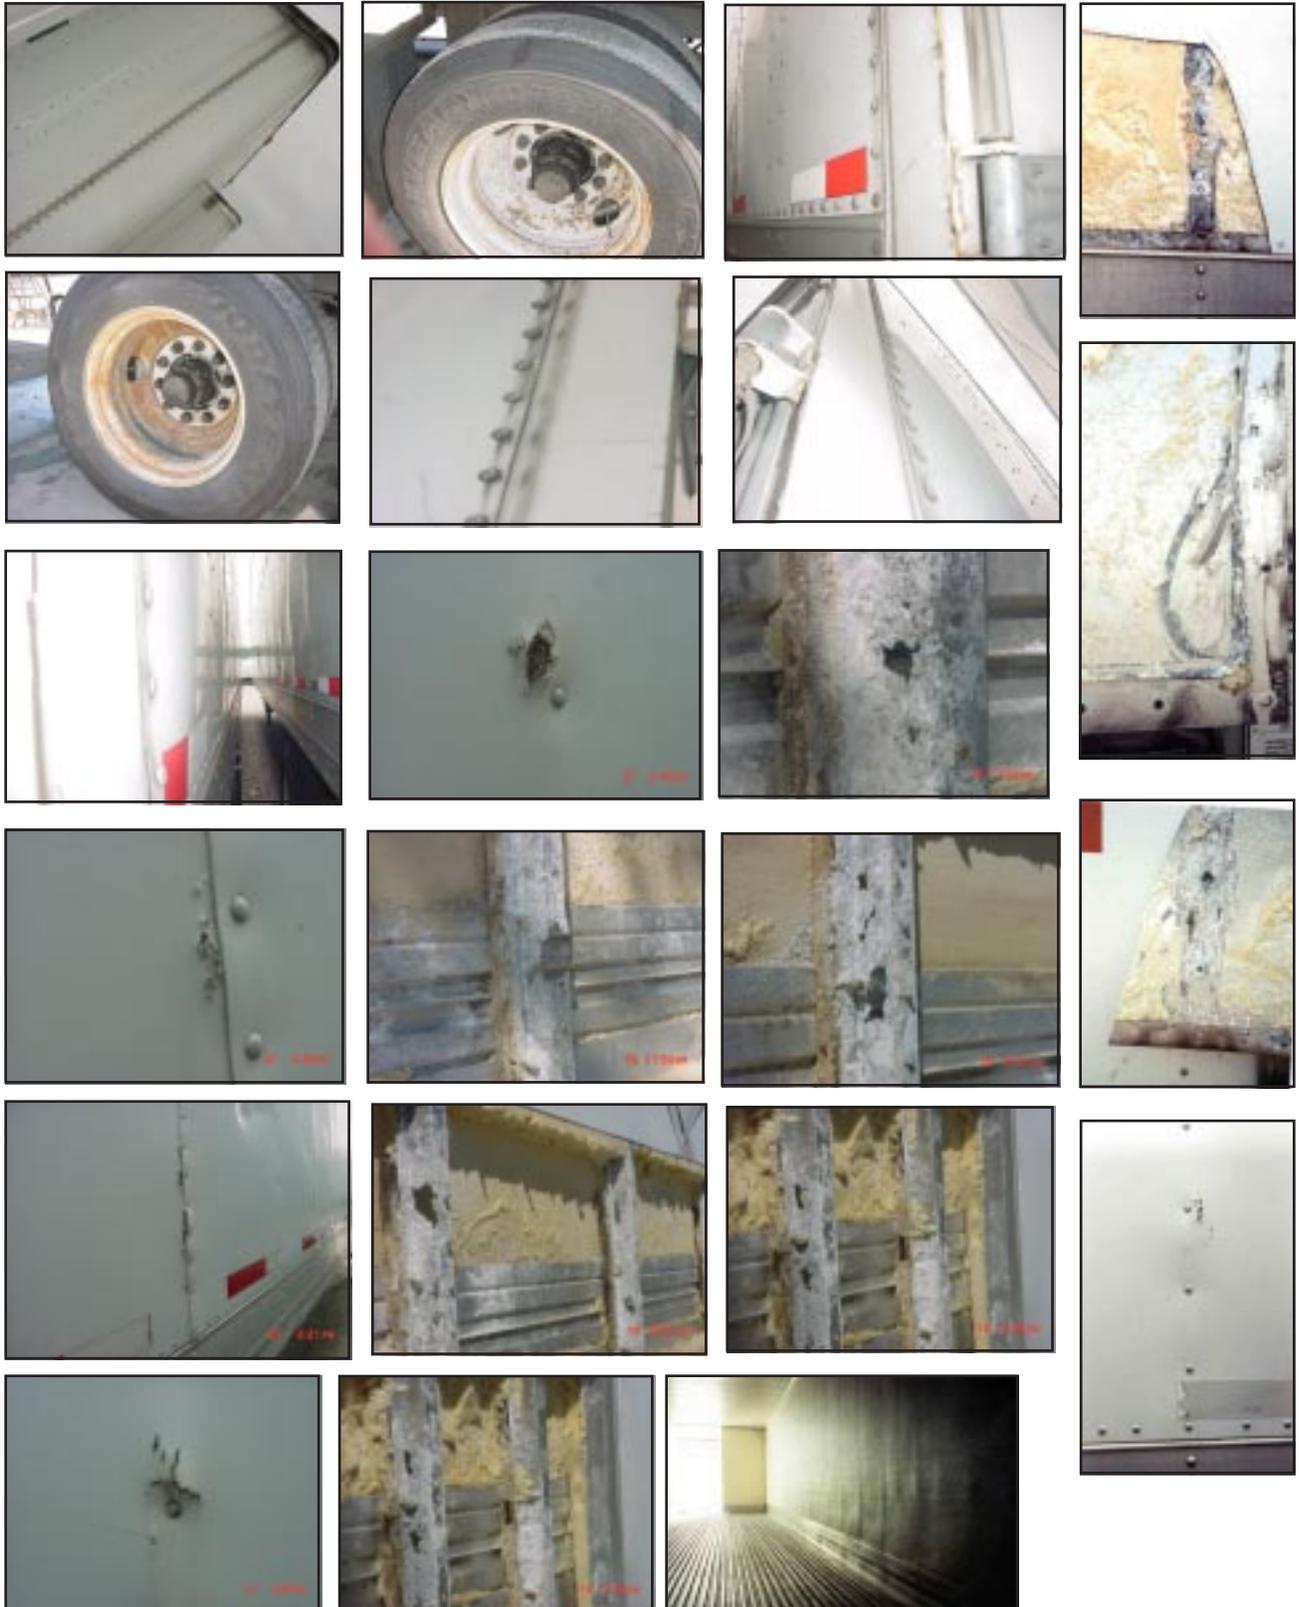
The following photos are examples of corrosion caused by new road ice clearing chemicals as described in this information report. What also follows are reprints from TMC's *Maintenance Manager Magazine* and *The Trailblazer*, also describing the problem.

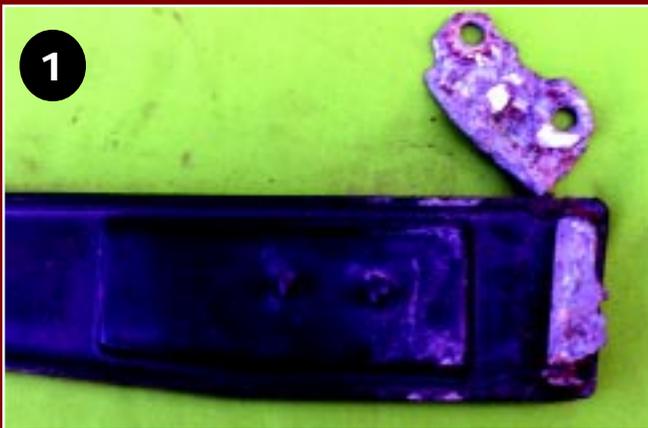
Corrosion Takes Its Toll

The following examples were all taken from late model vehicles.

1. Pedal hinge corroded
2. Bracket rusted through
3. Spring Hanger severely rusted
4. Trailer I beam rusted through
5. Corrosion in electrical socket

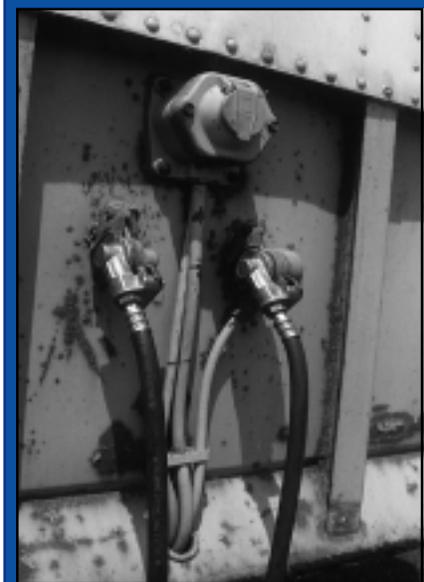
Designers reduced corrosion by eliminating entrapment areas where moisture and poultrice can be trapped or retained; they reduced the number of sharply angled meeting surfaces, “dead ends” and narrow openings; and they closed unneeded holes in body panels and provided better drainage.
